Uniform Mitigation Verification Inspection Form

Inspection Date: Oct 28, 2025		
Owner Information		
Owner Name: CARRIAGE HOMES AT LIVINGSTON LAKES		Contact Person:
Address: 15161 Palmer Lake Circle		Home Phone:
City: Naples	Zip: 34109	Work Phone:
County: Collier		Cell Phone:
Insurance Company:		Policy #:
Year of Home: 2016	# of Stories: 2	Email:

Inspectors Initials C N **Property Address** 15161 Palmer Lake Circle Naples 34109

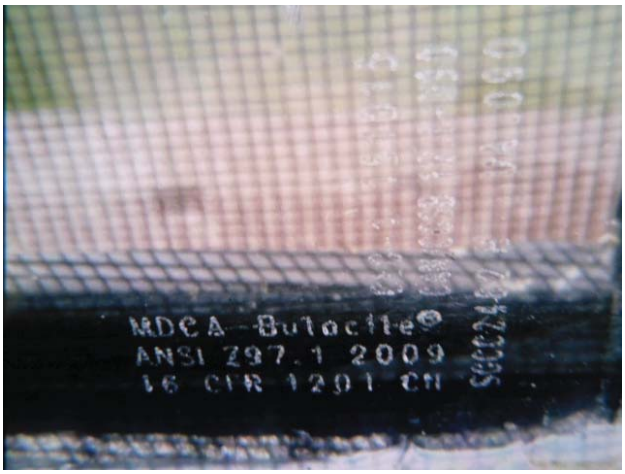
LAMINATED
ANSI Z97.1

MDCA-Butacite®
ANSI Z97.1 2009
16 CFR 1201 CH
