Chrisopher North Builders Inc

Uniform Mitigation Verification Inspection Form

Inspection Date: Oct 28, 2025		
Owner Information		
Owner Name: CARRIAGE HOMES AT LIVINGSTON LAKES		Contact Person:
Address: 15201 Butler Lake Drive		Home Phone:
City: Naples	Zip: 34109	Work Phone:
County: Collier		Cell Phone:
Insurance Company:		Policy #:
Year of Home: 2015	# of Stories: 2	Email:

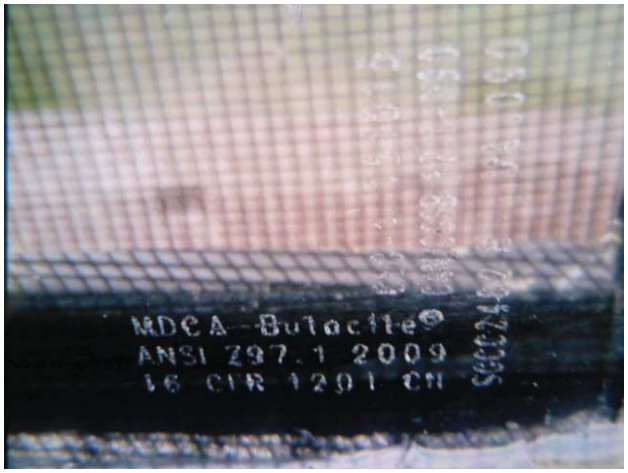
MDCA-Butacite®
ANSI Z97.1 2009

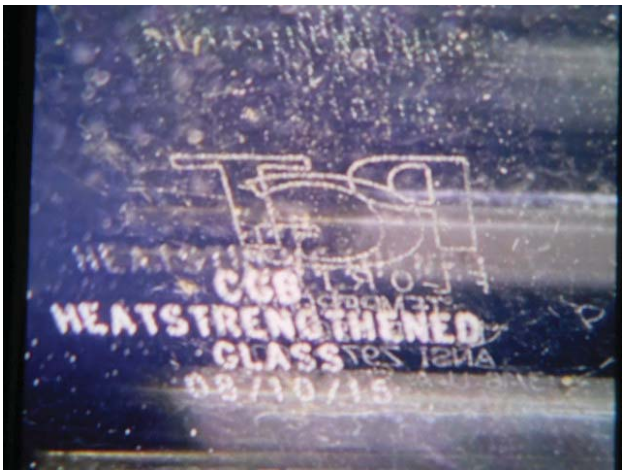
MDCA-Butacite®
ANSI Z97.1 2009
16 CFR 1201 CN

CGB
HEATSTRENGTHENED
GLASS
